Mesa Active Adult Center

Facilities Assessment Preliminary Cost Estimate & CDBG Grant Request

DRAFT November 2014

Michael Wilson Kelly-Architects, Ltd.

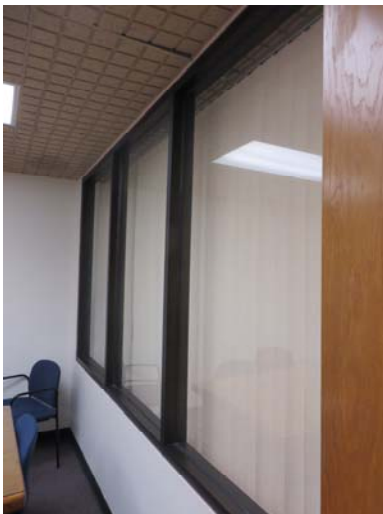
Unused, unnecessary windows between Administrative office and Conference room in Improvement Area 10. Unused reception window in the Home Delivery Office opening to the Corridor. Serious need for a Home Delivery Manager's Office and a more secured, organized Storage Room for the wheelchairs and walkers loan program.

Unused windows between Office & Conference Room should be filled in.

There are a few locations, as illustrated in IMPROVEMENT AREAS 6 & 10, where unnecessary windows need to be removed and walls filled in with metal studs and drywall. Acoustical sound batt insulation should be added to improve privacy and reduce noise. Match existing light orange peel drywall texture and paint to match adjacent existing color. Provide matching wall base where occurs.

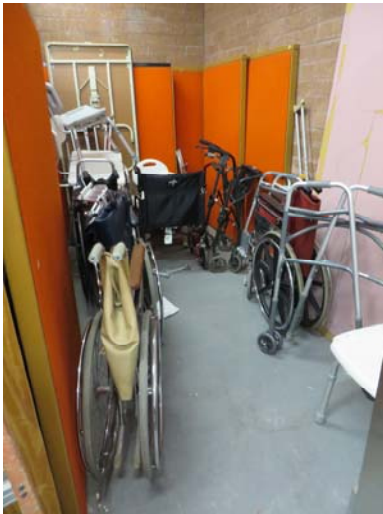
Need for organized & secured Storage Room
for walkers & wheelchairs

Some minor demolition, new non-structural metal stud walls with miscellaneous wall patch and repair are required In IMPROVEMENT AREAS 6 & 8 to create a private office for the Home Delivery Food Manager, a locked Storage closet for wheelchairs and walkers that are loaned out. In Area 8, a new Walk-in Flash Freezer will replace 4 existing free-standing flash freezers.

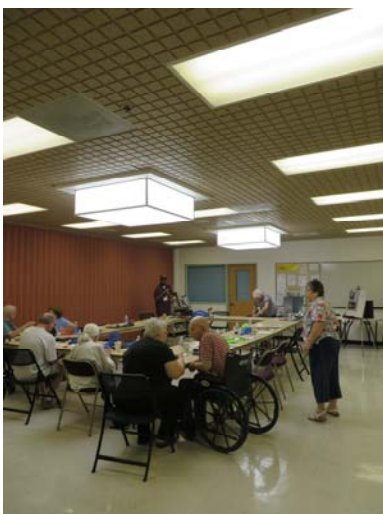
ACOUSTICAL CELING TILES: (All Areas) The majority of the acoustical ceiling tiles are in good shape, but whenever there is the slightest leak or unintended damage occurs via repeated maintenance access, these ceiling tiles can become damaged and cannot be replaced as original specified. Their color is warm and friendly, but reduces overall light reflectance value via the predominantly indirect lighting fixtures. Later additions to the building do not have matching ceiling tiles. Those tiles are non-gridded and were painted to match, which reduces their overall acoustical effectiveness. The gridded tiles also look "dated".

CLASSROOM SKYLIGHTS: (Areas 4 & 5) The existing dual 4 ft square skylight diffusers in each Classroom protrude downward into the space and are disruptive during low light A/V media presentations and are a source of heat gain during the hot summer months.

ACOUSTICAL CELING TILES: (All Areas) While there is no immediate urgency, we recommend a complete replacement of all acoustical ceiling tiles to update their look and effectiveness providing a greater light reflectance value and a higher noise reduction coefficient. Use a more universal standard ceiling tile per City of Mesa Facilities Dept. recommendations in order to insure plenty of back-stock for periodic replacements.

CLASSROOM SKYLIGHTS: (Areas 4 & 5) Remove the protruding plastic light diffusers and infill frame the openings to be flush with existing gypsum board soffit surrounds. Provide ceiling fans with LED dimmable lighting at each location (centered).

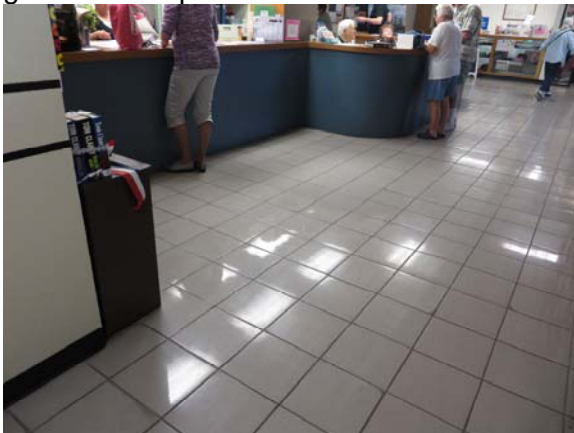
There are several existing flooring types in the building including various ceramic tile, broadloom roll carpet, 12 X 12 vinyl composition tiles (VCT), 3 inch wide tongue & groove wood plank floors and sealed concrete.

The high traffic Lobby and adjacent circulation areas have original white 12 X 12 ceramic flooring tiles that look dated, cause acoustical reverberation and are hard on the Seniors' knees and joints. Restroom ceramic tiles have a decorative accent border. The high use Multi-Purpose Room has original wood plank "gym" flooring that is showing wear and exhibits multiple layers of clouded polyurethane finish. The white glued down VCT used in Classrooms 1 & 2 requires high maintenance, waxing, is acoustically loud, and their edges are vulnerable to water damage. The broadloom carpets show wear in high traffic areas that can't be matched or repaired.

Lobby and other adjacent high traffic areas: Remove existing tile and replace with engineered wood plank flooring with a 50-year polyurethane factory finish requiring only wet mop maintenance while improving acoustics, easing wear on Senior's knees and joints, and adding a sense of warmth and welcome.

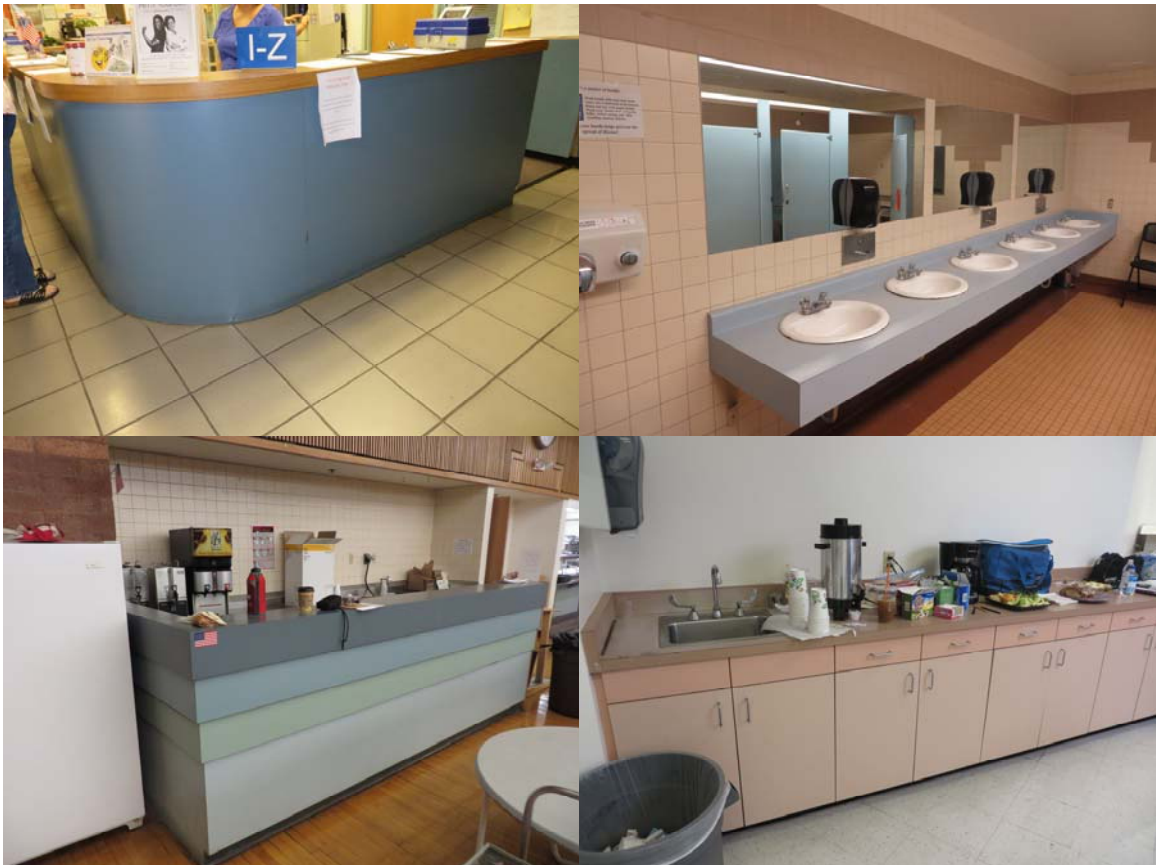
The existing Millwork consists of multiple colors and widely varying combinations of plastic laminate (Formica type) counters and cabinets.

All the millwork cabinets and countertops are dilapidated and their widely varying color schemes are very dated. All countertops with sinks and backsplashes are exhibiting water caused de-lamination and fading color making them nearly impossible to match or repair. Many of the counters do not meet current ADA accessibility requirements for height, service, and knee clearances. Some of the cabinets that need to be locked are chained together via their hardware pulls.

RECEPTION: (Area 1) Unify with new finishes and modify the main reception counter to provide ADA accessible service. Replace the Administrative Offices Reception Counter entirely to meet ADA accessibility standards. Provide solid surface countertops and re-laminate with matching plastic laminate.

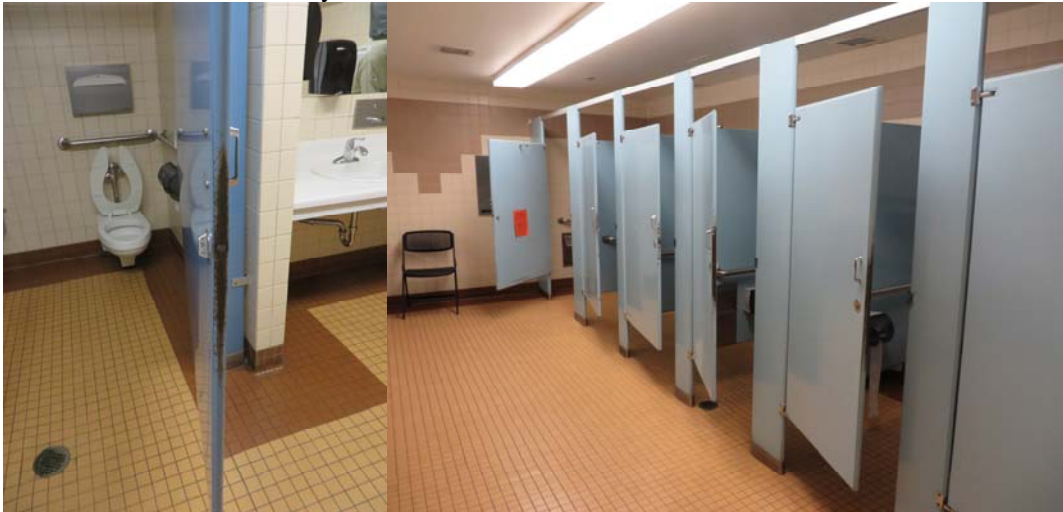
The existing Toilet Partitions are original metal wall and floor hung partitions, painted lighter blue (Women's) and darker blue (Men's).

The Toilet Partitions are worn, soiled, out of plumb, and in need of modification to meet modern ADA accessibility standards.

RESTROOMS (Areas 3 & 9): Replace all Toilet Partitions and remodel for an ADA accessible toilet enclosure in both the Men's & Women's Restrooms at Improvement Area 3. Provide out-swinging doors at these stalls. One inch thick HDME solid integral color plastic wall and floor hung partitions complimentary in color to the existing ceramic floor tile and color coordinated proposed new solid surface (Corian or equal) sink countertops is recommended.
